NASA/TM—2005—212559

Debris/Ice/TPS Assessment and Integrated Photographic Analysis of Shuttle Mission STS-111

Author Name: Armando Oliu

June 2005

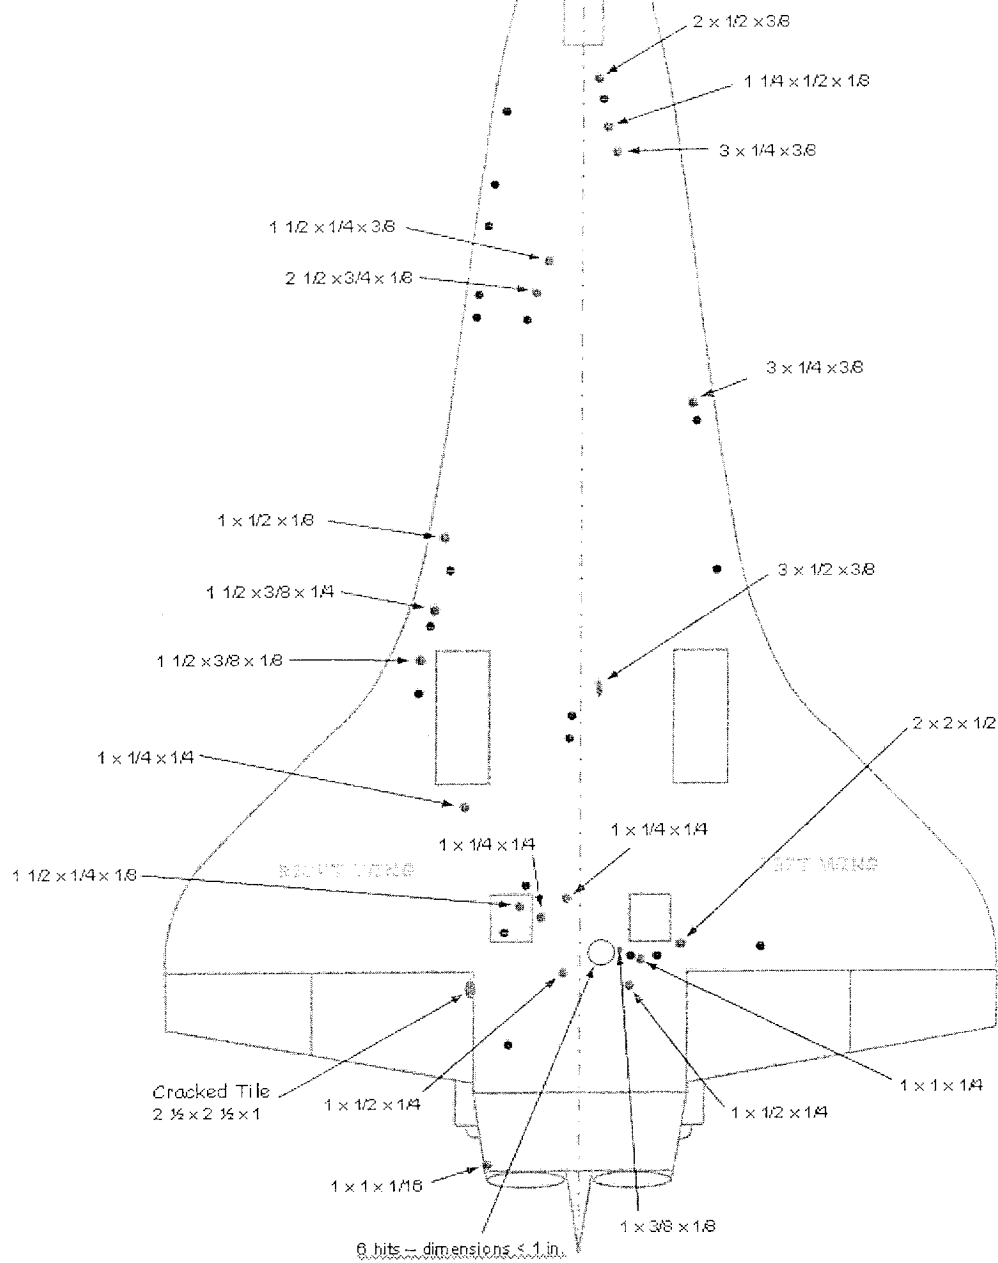
Figure 1: Orbiter Lower Surface Debris Damage Map

Hits > 1 inch = 21

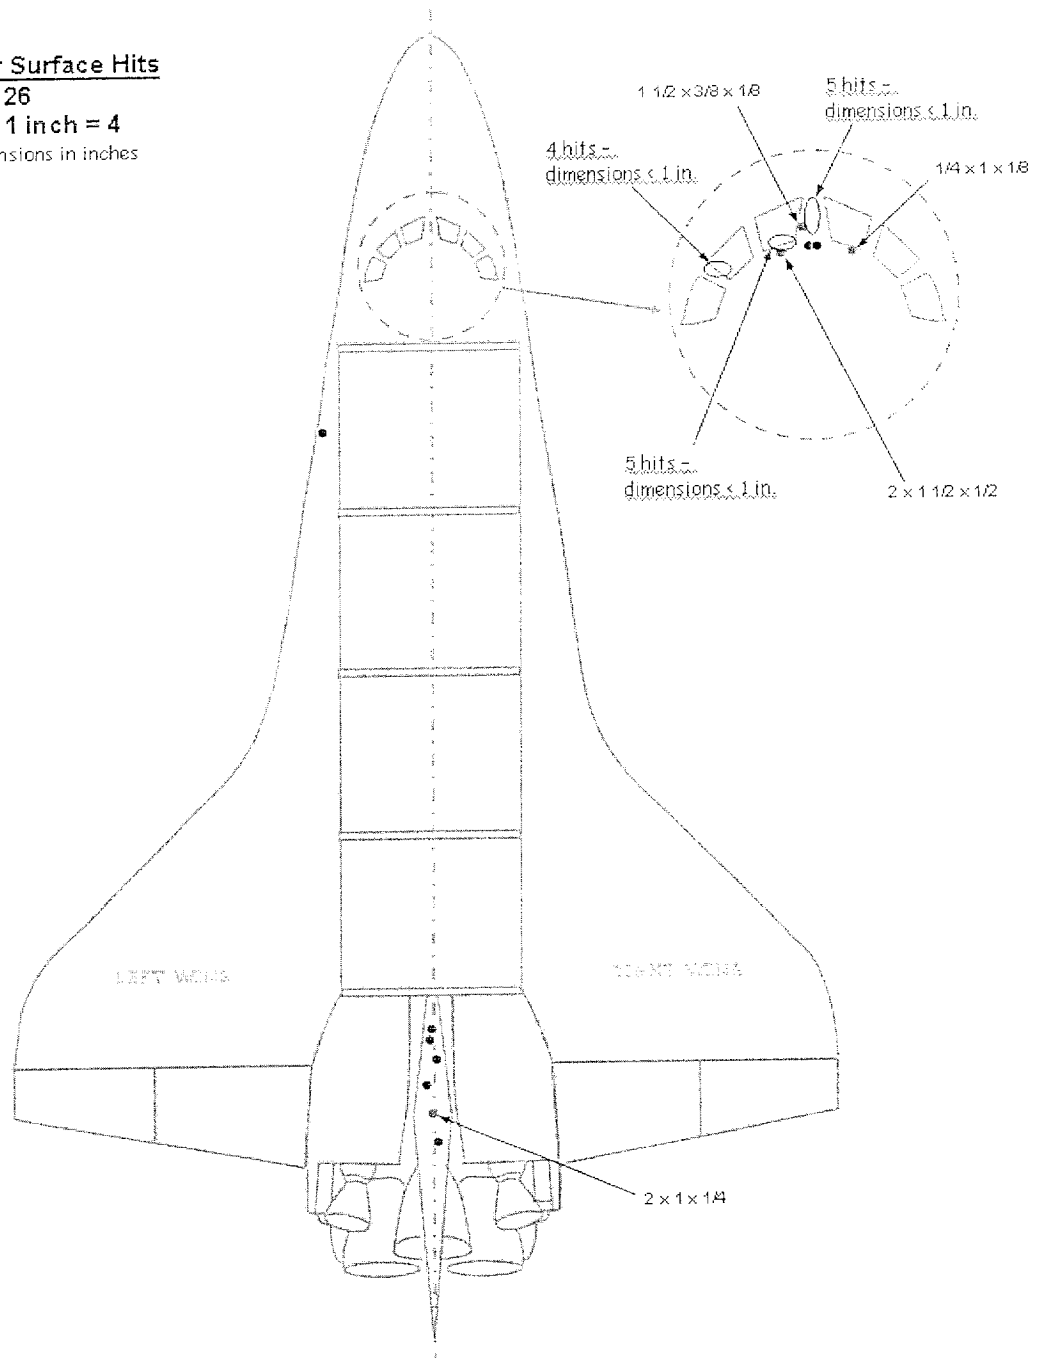
Figure 2: Orbiter Upper Surface Debris Damage Map

Hits > 1 inch = 4

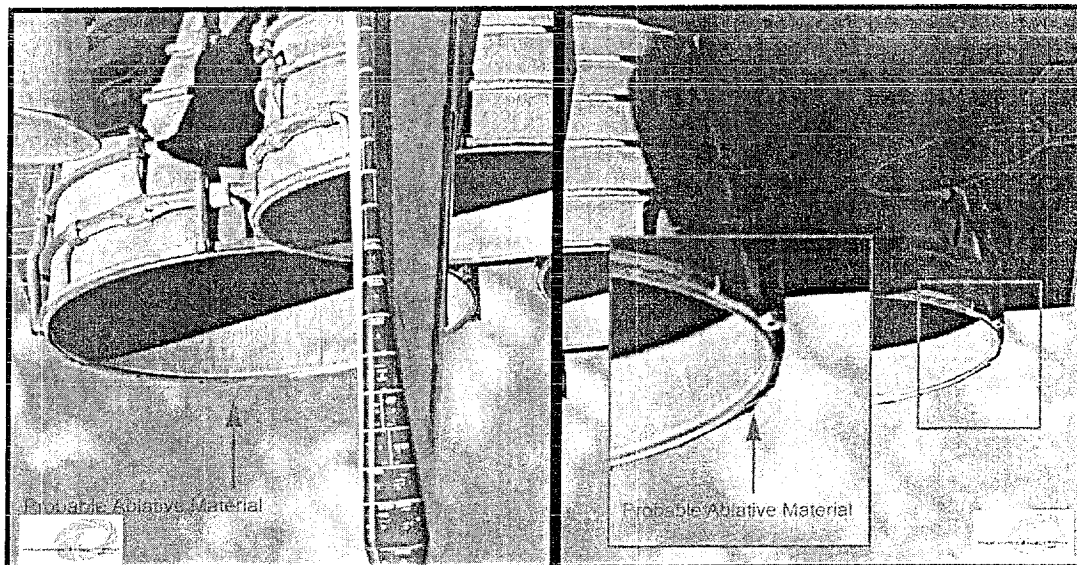
Figure 2.1 (D) Ablative Material on SSME Rims Seen On-Orbit (ISS004E13276)

CFVR-111-03: Ablative Material Protruding from -Z Rim of SSME #2 and from the +Y Rim of SSME #3

Thin, red colored objects (ablative material) were seen protruding from the edge of the -Z rim of SSME #2 and from the +Y edge of SSME #3 on the downlinked digital imagery prior to landing.

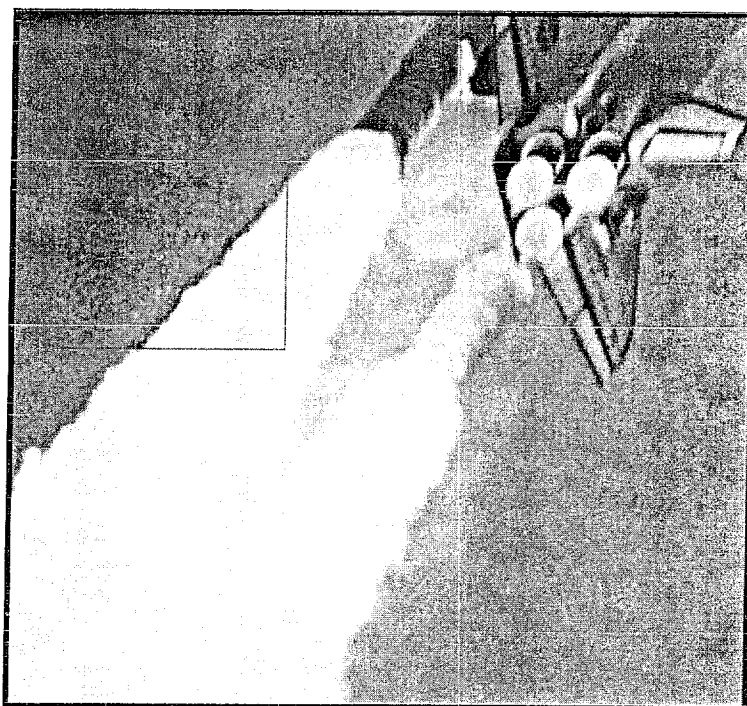
Figure 2.2.2 (A) Spray of Debris Exiting the LSRB Exhaust Plume (Camera E52)

Numerous pieces of debris (in excess of twenty) were seen falling aft from the LSRB exhaust plume near the LSRB aft skirt during early ascent (21:23:06.439 UTC). See Figure 2.2.2 (A). The debris occurred simultaneously on both sides of the LSRB exhaust plume. Approximately two seconds later, a second spray of debris (at least fifteen in number) was again seen in the same location on both sides of the LSRB exhaust plume

(21:23:08.287 UTC). Although debris exiting the SRB exhaust plumes has been typically seen on previous mission imagery, this event is considered unusual because of the amount (not size) of debris that was visible. (Camera E52)

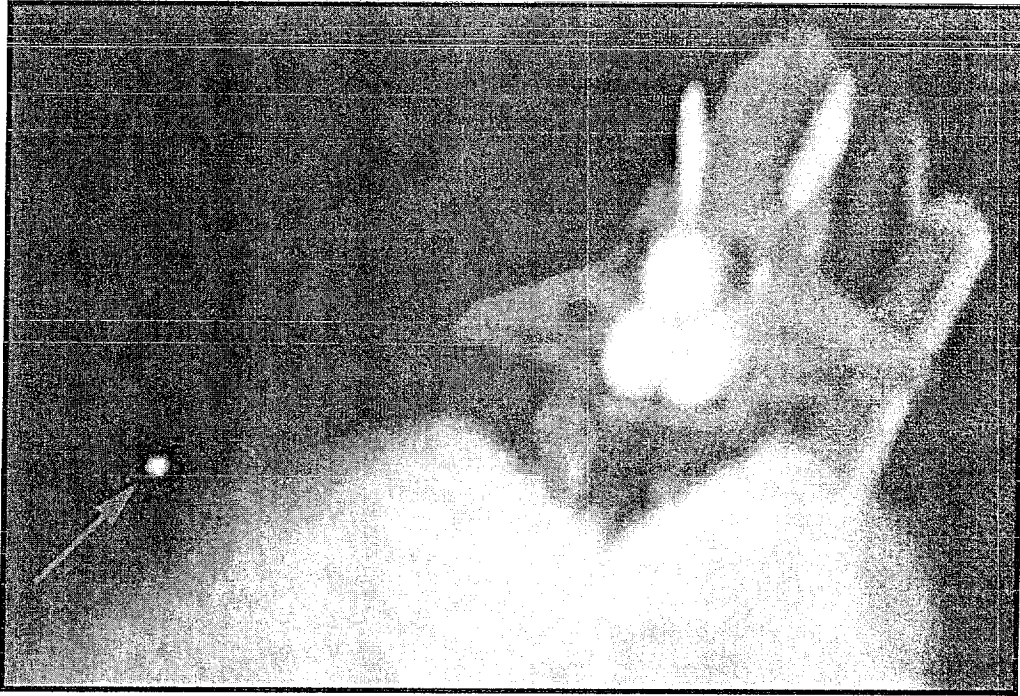
**Figure 2.2.2 (B) Debris Seen Exiting the SRB Exhaust Plume During Ascent
(Camera E207)**

Other debris was also seen exiting the SRB exhaust plumes late during ascent. The debris exiting the SRB exhaust plumes during late ascent was probably instafoam from the aft end of the SRB's. See Figure 2.2.2 (B). The more dense appearing debris near the time of tail-off, just prior to SRB separation, was probably SRB slag debris. Examples of this debris are provided in Table 2.2.2 (B).

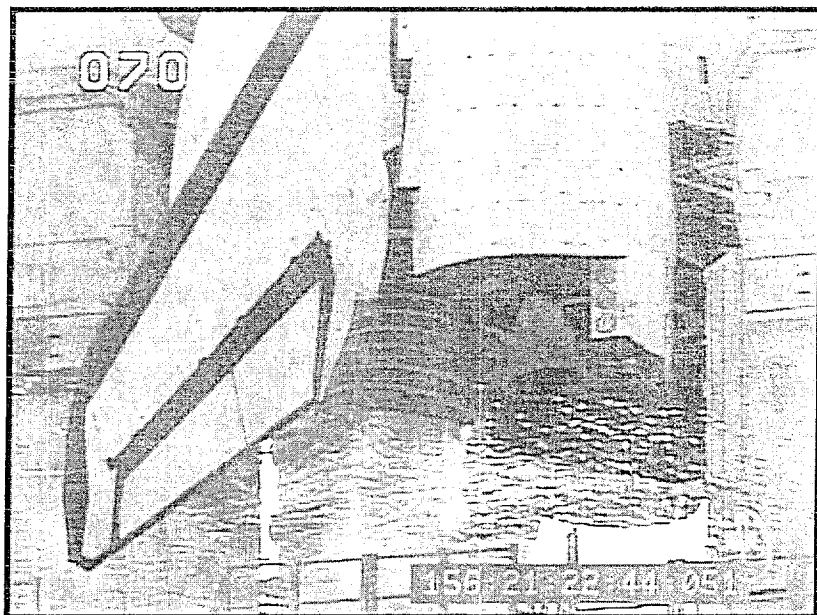
**Figure 2.2.3 (A) Orange Vapor Seen Forward of SSME Rims Prior to Liftoff
(Camera OTV070)**

Orange vapor (possibly free burning hydrogen) was seen forward of the SSME rims, near the base heat shield, near the trailing edge of the vertical stabilizer, near the drag chute door, and on the $-Z$ side of the body flap, during SSME ignition (21:22:44.021 UTC). See Figure 2.2.3 (A). With the exception of the orange-colored flash described under section 2.1, the orange vapor on the STS-111 films appeared to be similar to those typically seen on previous mission films and videos. (Cameras E2, E18, E20, E76, OTV063, OTV070)

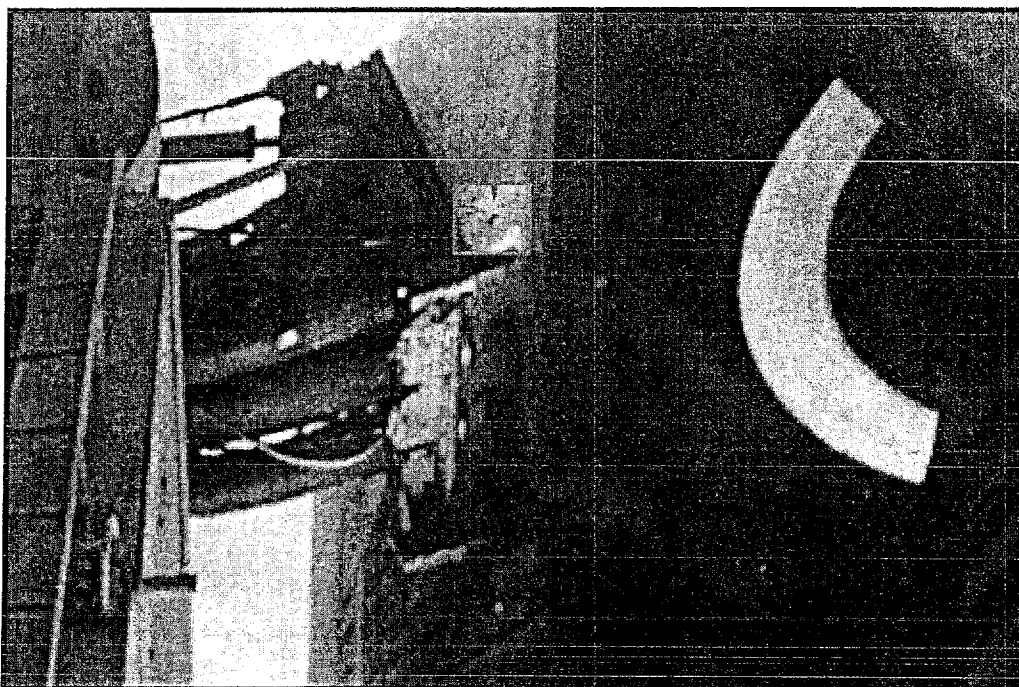
**Figure 2.2.3 (B) Ground Strap Seen During LO2 TSM T-0 Umbilical Retraction
(Camera E17)**

A small, dark-colored, object was seen trailing the LO2 TSM T-0 umbilical during retraction (21:22:49.406 UTC). The object appeared to follow the T-0 umbilical toward the LO2 TSM before being lost from view. See Figure 2.2.3 (B). KSC reported that this object was the grounding strap that goes from the LO2 TSM to the Orbiter. Normally the grounding strap is obscured by vapors and is not visible. (Camera E17)

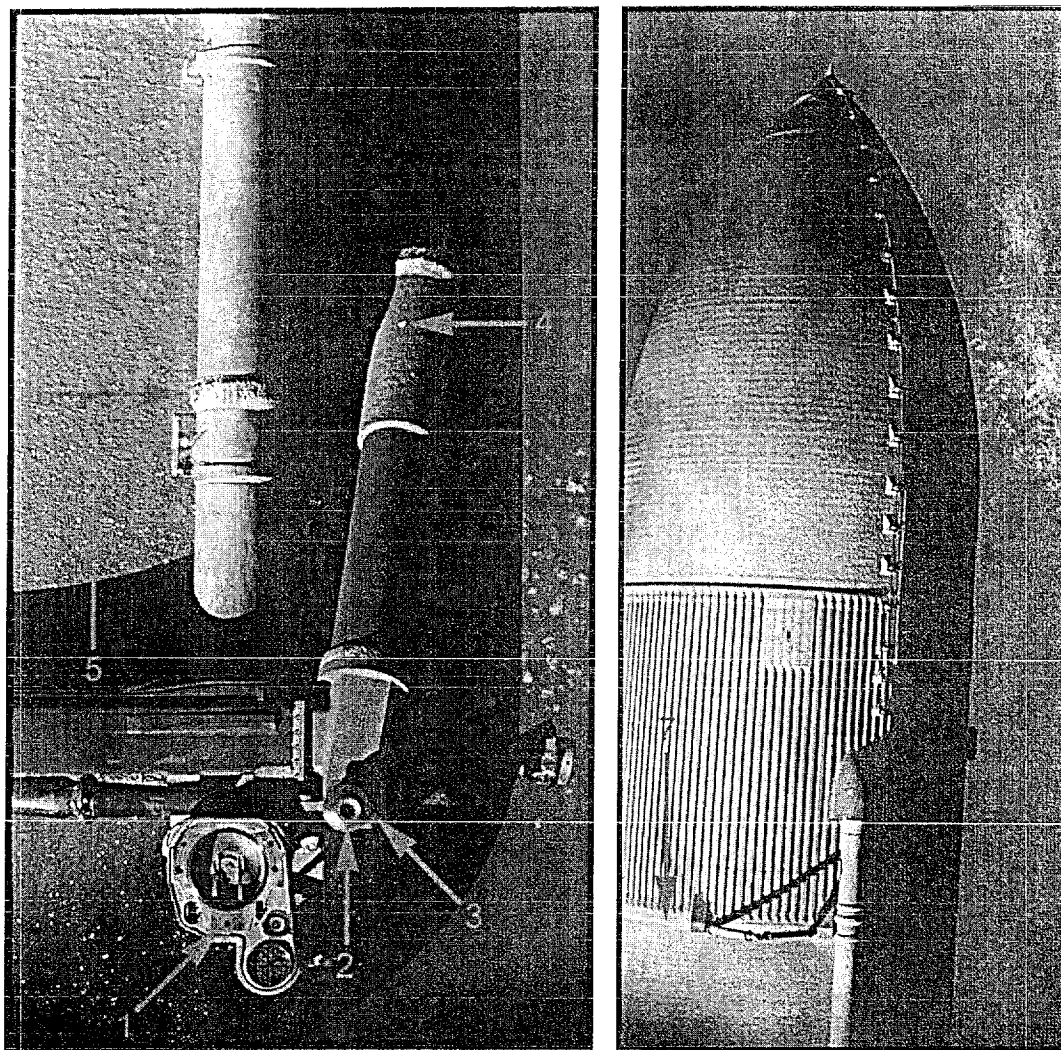
Figure 2.3.1 (A) 35mm Images of the ET during Separation (Frames 11 and 48)

The face of the LO2 umbilical carrier plate appeared to be in excellent condition (no indication of damaged or missing lightning contact strips was detected). See Figure 2.3.1 (A), annotation 1.

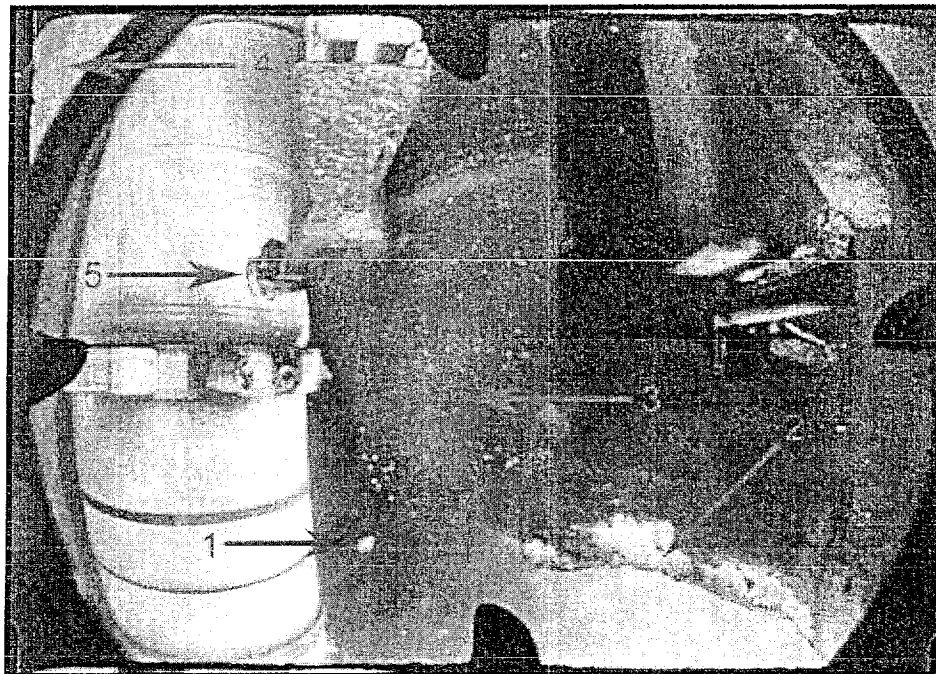
Figure 2.3.2 (A) 16mm Umbilical Well Camera SRB Separation Image

A slight rebound motion (twang) of the EB9 interface at the SRB / ET upper aft stabilization strut was visible during the LSRB separation. See Figure 2.3.2 (A), annotation 5. This motion was compared to the same umbilical well camera view from STS-109. An identical motion was also observed on the STS-109 film.

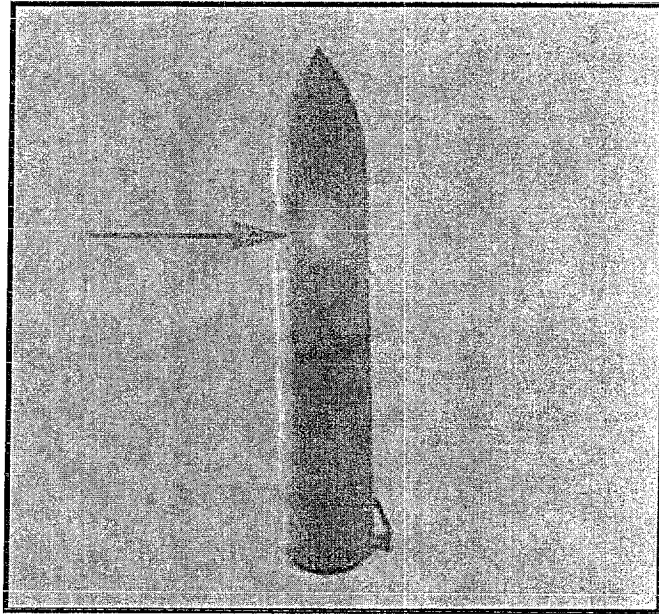
Figure 2.3.4 View of ET Venting After Separation

The astronauts acquired 8.3 minutes of handheld video of the ET on STS-111. Vapors coming from the ET intertank vent were noted. See Figure 2.3.4. Vapors coming from the ET intertank after separation have been seen on previous mission videos. No timing data was present on the video.

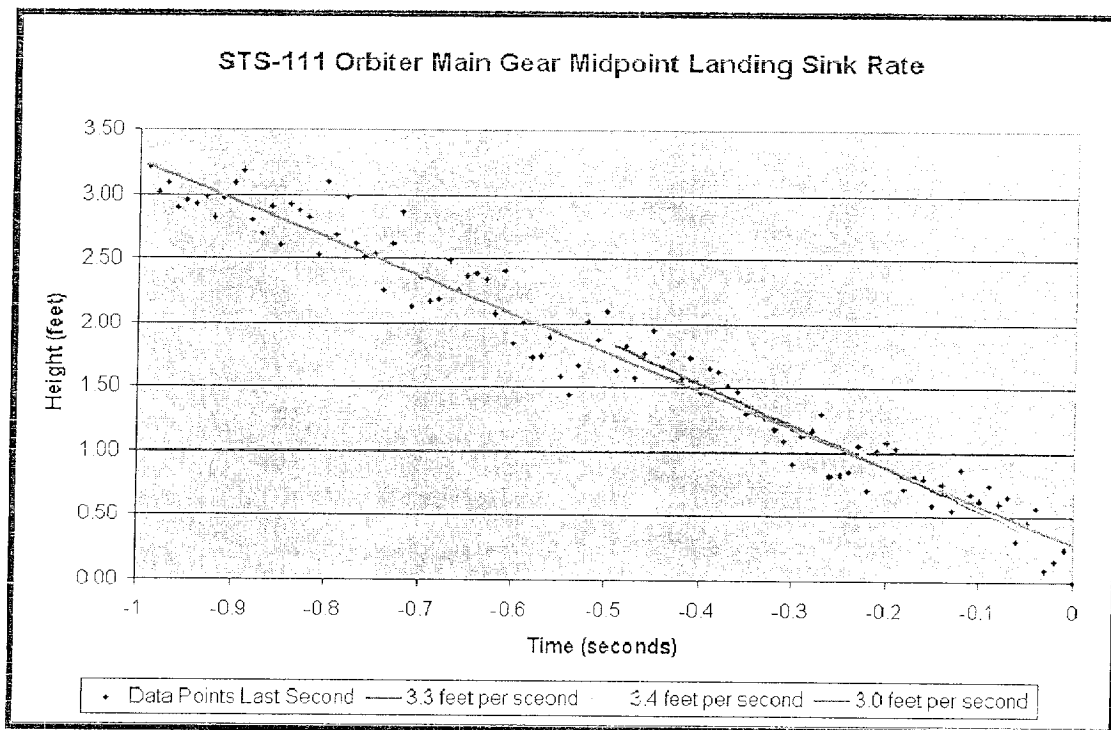
Figure 2.5 Main Gear Midpoint Landing Sink Rate

The maximum allowable main gear sink rate values are 9.6 feet/second for a 212,000 lb. vehicle and 6.0 feet/second for a 240,000 lb. vehicle. The landing weight of the STS-111 vehicle was reported to be 220,173 lbs.

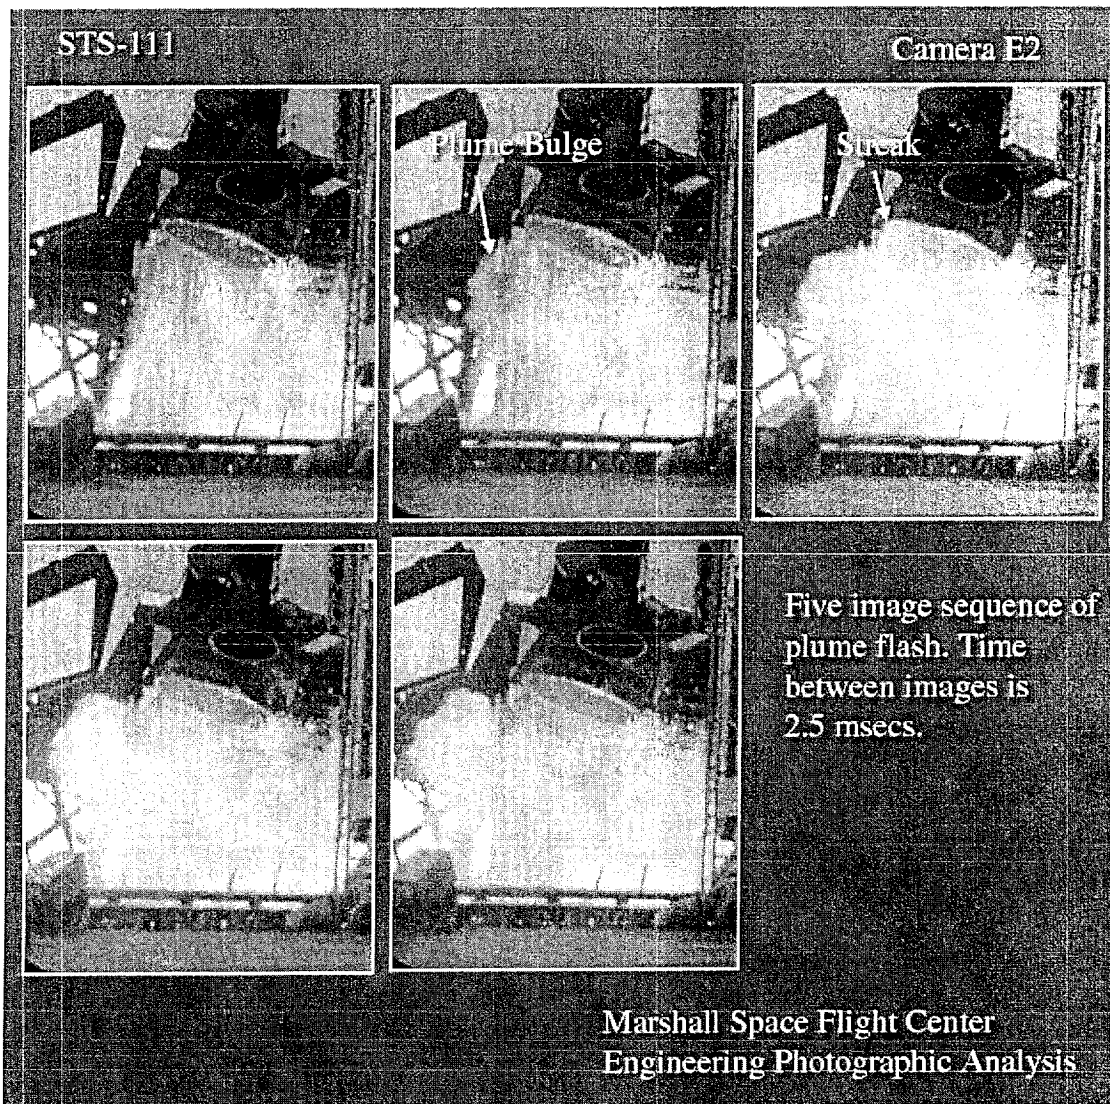
Figure 1. E2: SSME#1 Plume Flash Sequence

Typically, reddish-orange free burning Hydrogen flashes are observed just after fuel lead during SSME ignition. This particular flash occurred as flow entrainment is being established and appears to initiate from a disturbance inside SSME #1 nozzle. A bulge in the plume, Figure 1, was observed in the frame just prior to the flash. Also, a band-like area of flow separation was noted as this event initiated, Figure 2.

SSME Project Office reported no concerns with this plume flash after reviewing available data.

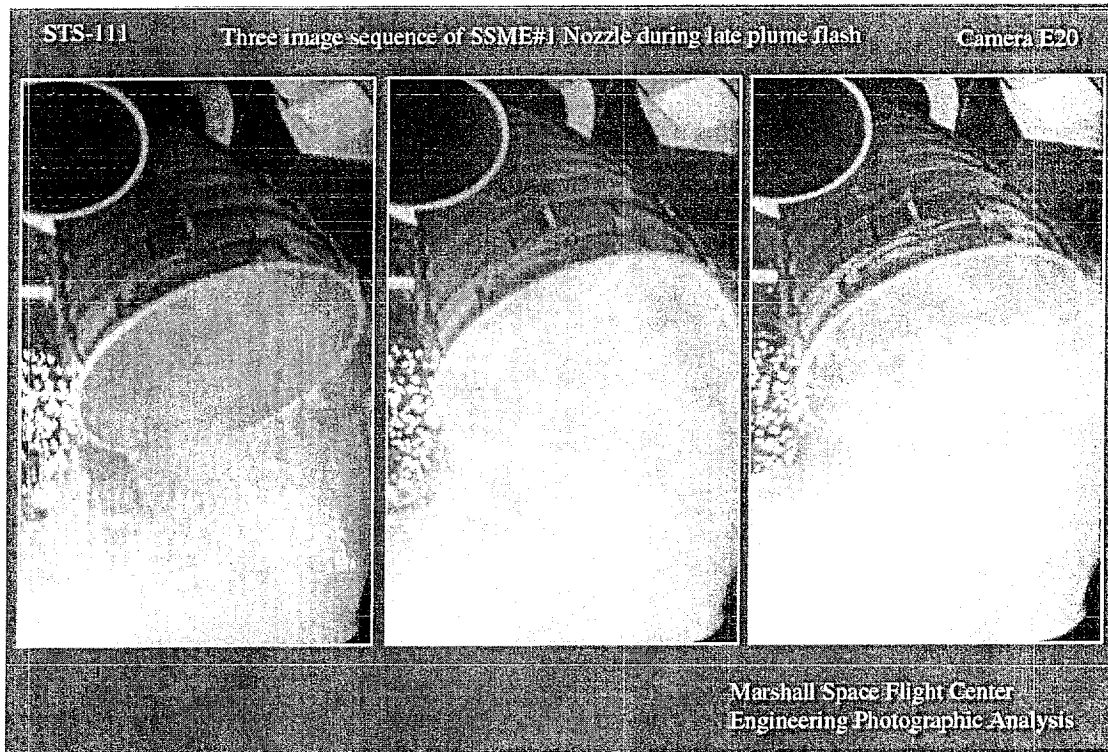
Figure 2. E20: SSME#1 Plume Flash Sequence

Shown below are a sequence of images that illustrate the flow separation characteristics that initiate the plume flash event in SSME#1.

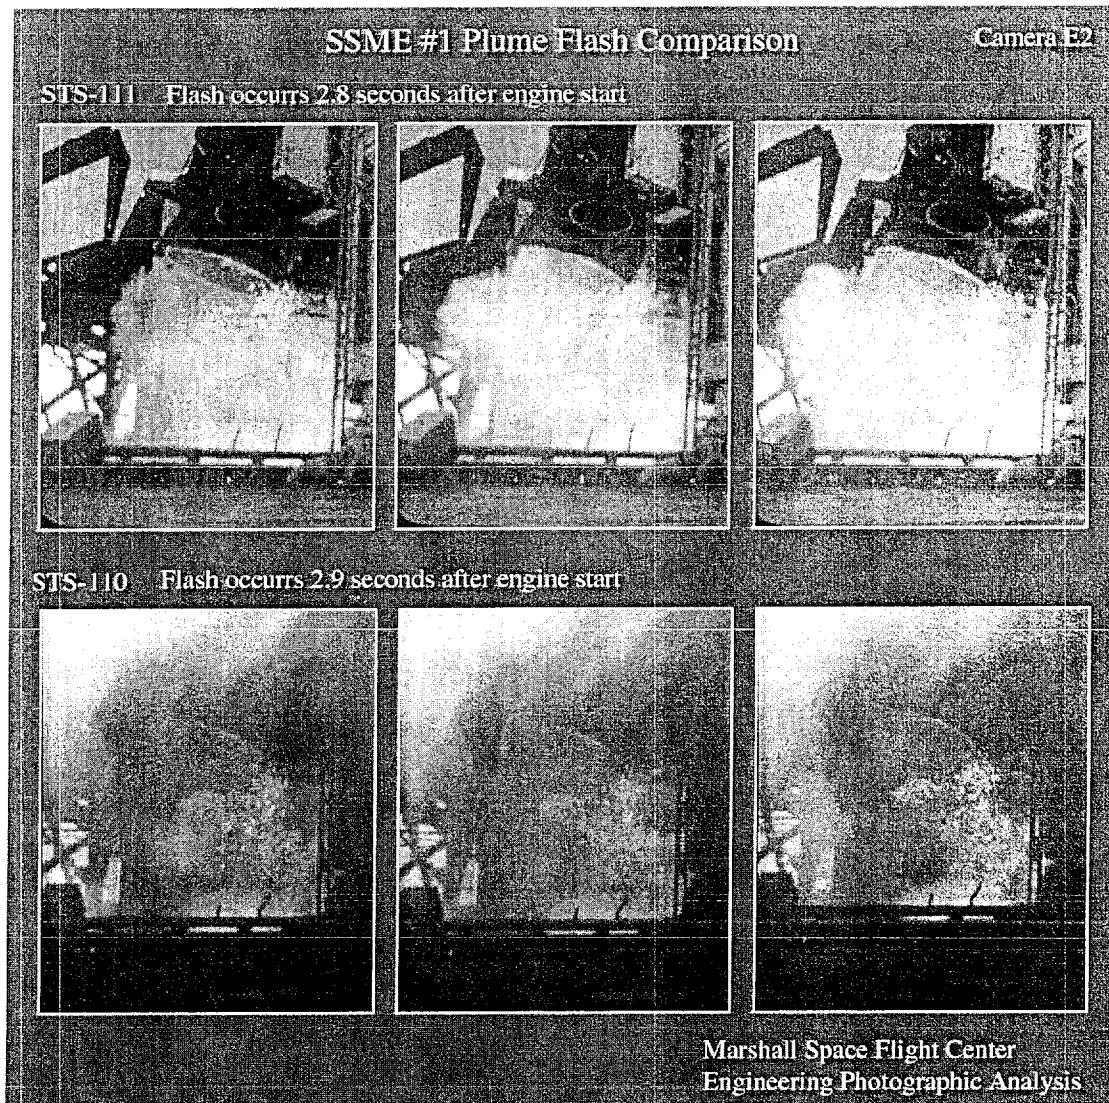
Figure 3. E2: STS-111 and STS-110 SSME#1 Plume Flash Comparison Sequence

The plume flash event in STS-110 was timed at 20:44:15.605 UTC, 2.906 seconds after SSME#1 engine start. The plume flash event in STS-110 was timed at 21:22:45.538 UTC, 2.846 seconds after SSME#1 engine start.

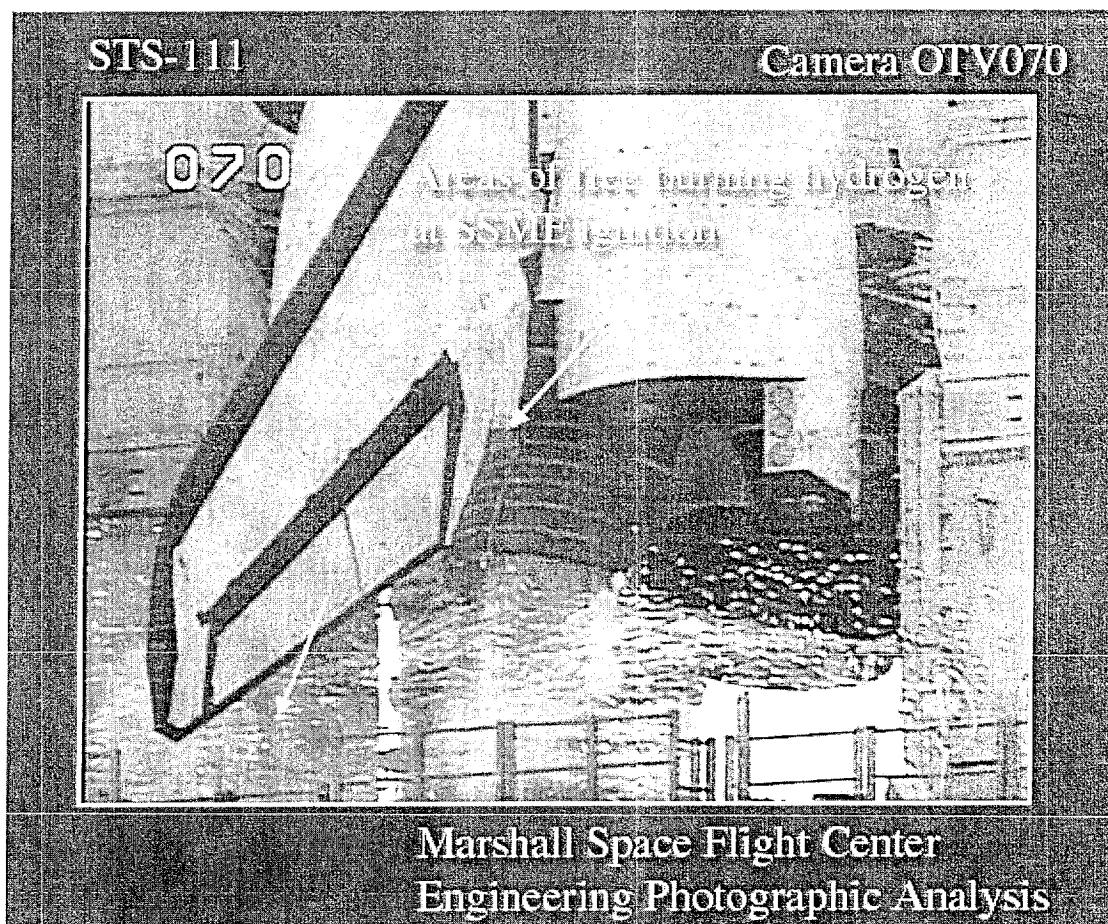
Figure 12. OTV070: Free Burning Hydrogen

Free burning Hydrogen was observed in the vicinity of the drag chute door and vertical stabilizer. Free burning Hydrogen has previously been observed at SSME startup in these areas.

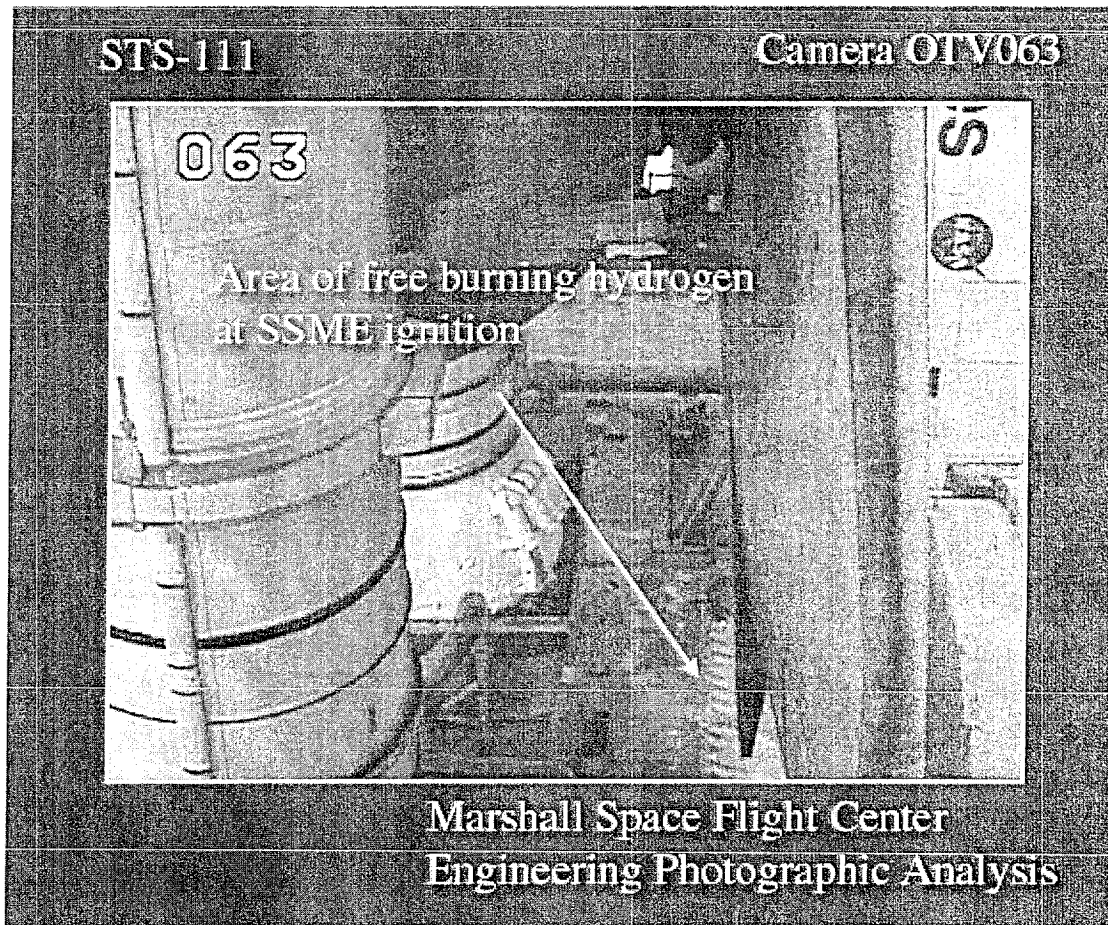
Figure 13. OTV063: Free Burning Hydrogen

Free burning Hydrogen was observed on the -Z side of the body flap at SSME startup. Free burning Hydrogen has been observed on the -Z side of the body flap on previous missions.

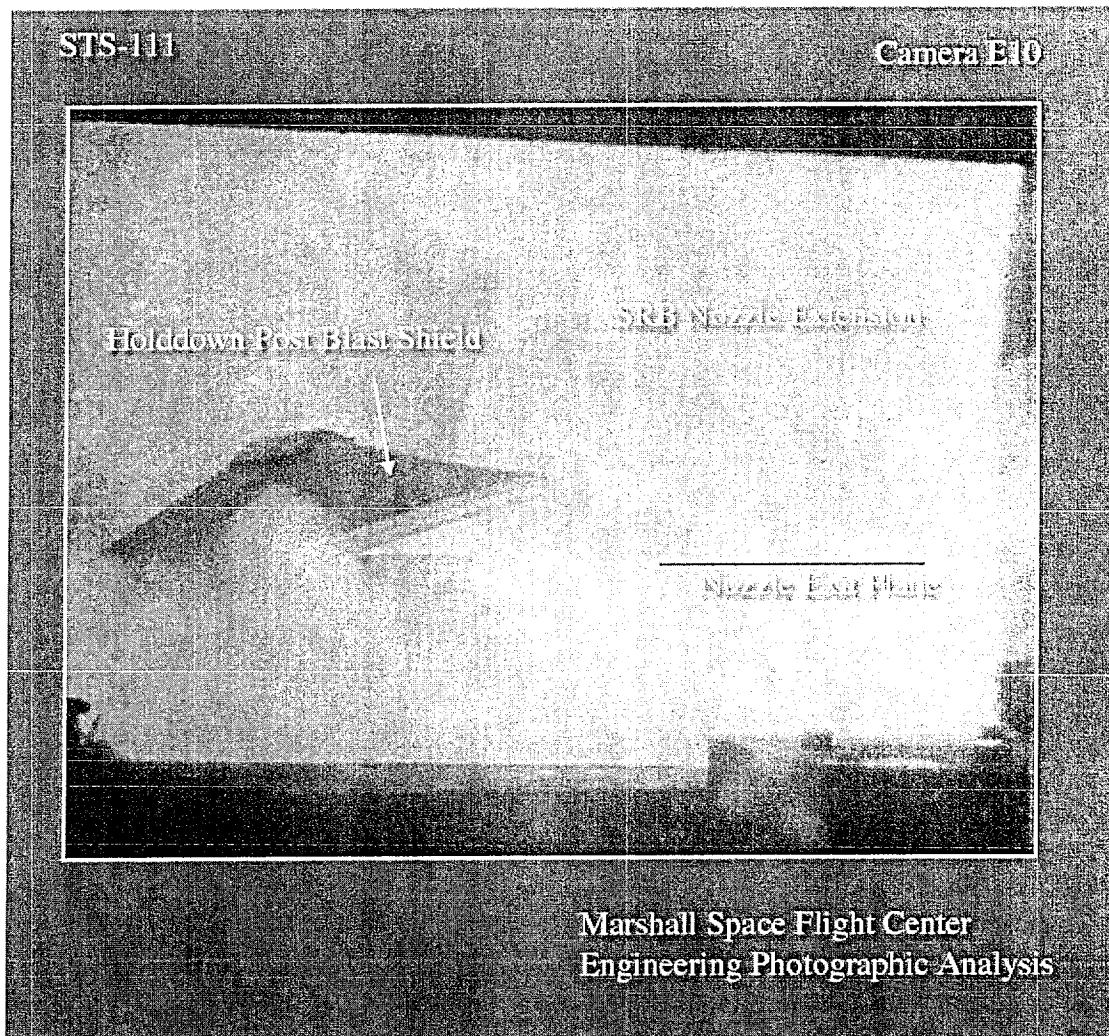
Figure 18. E10: Blast Deflection Shield Descent

A review of film from camera E10 for the last mission utilizing MLP-1, STS-108, also revealed a similar phenomenon.

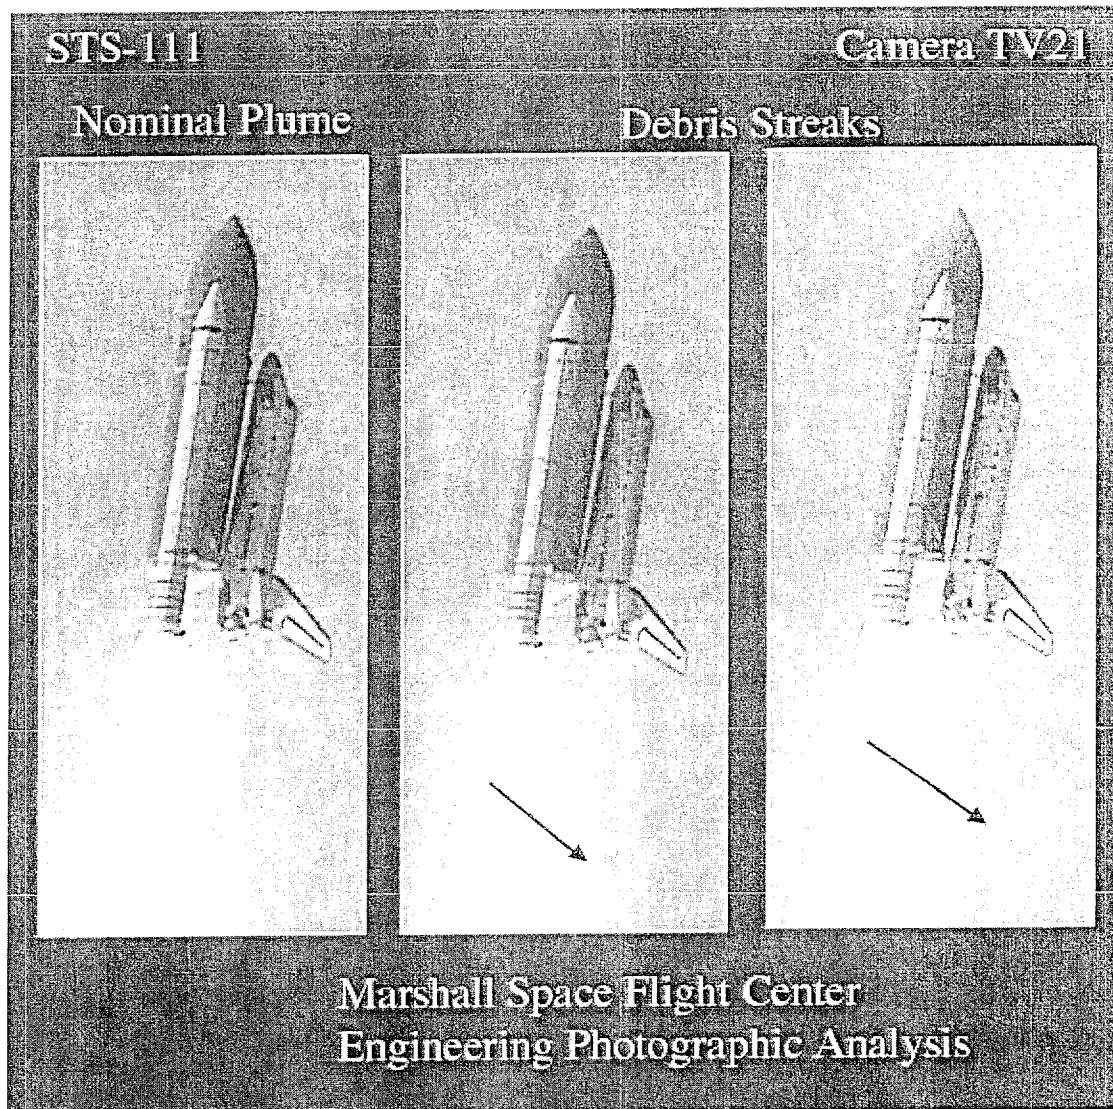
Figure 20. TV21: Debris-induced Streaks in SSME Plumes

Debris-induced streaks were observed in SSME plumes during ascent.

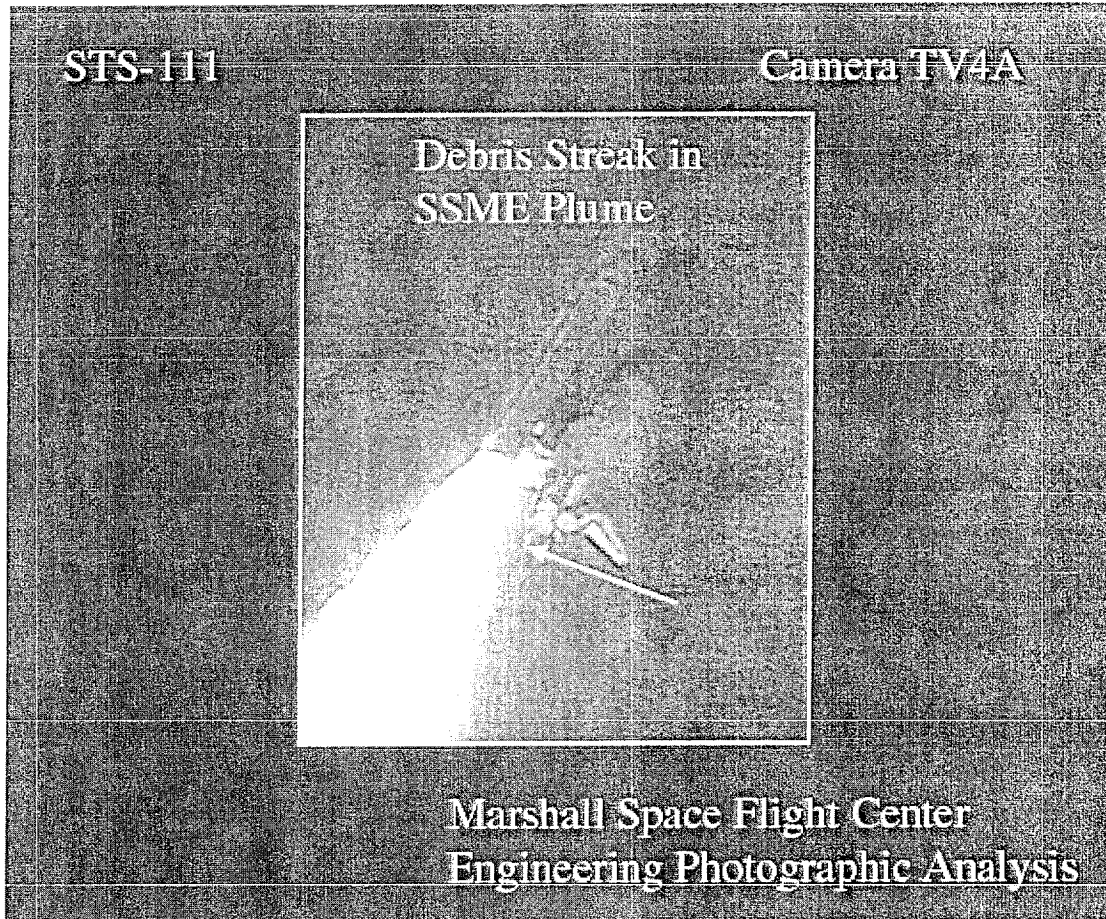
Figure 21. TV4A: Debris-induced Streaks in SSME Plumes

Debris-induced streaks were observed in SSME plumes during ascent.

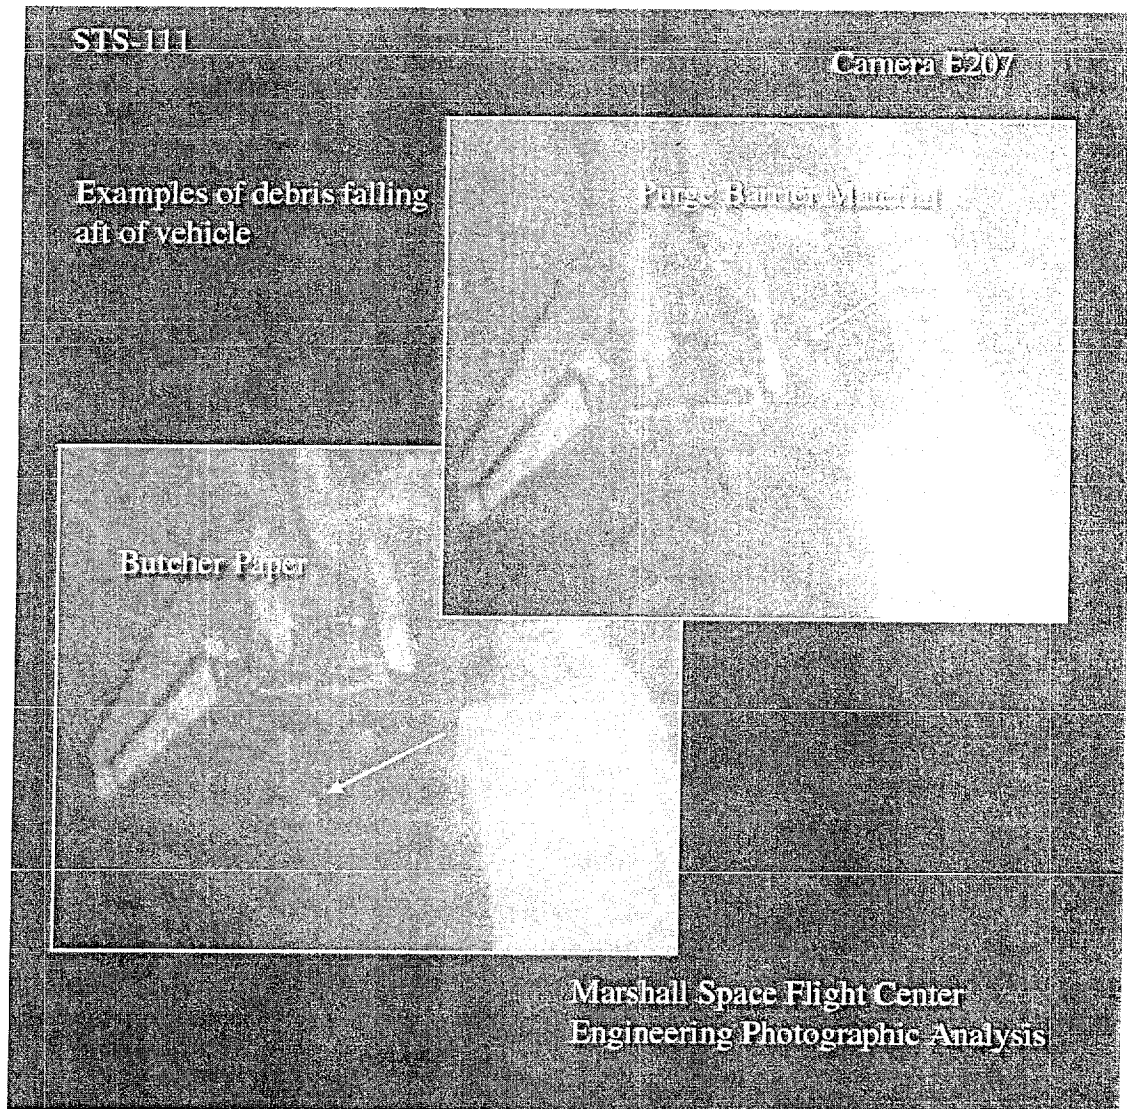
Figure 23. E207: Examples of Debris Falling Aft

Typical sources of debris falling aft of the vehicle during ascent are Purge Barrier Material and Butcher Paper.

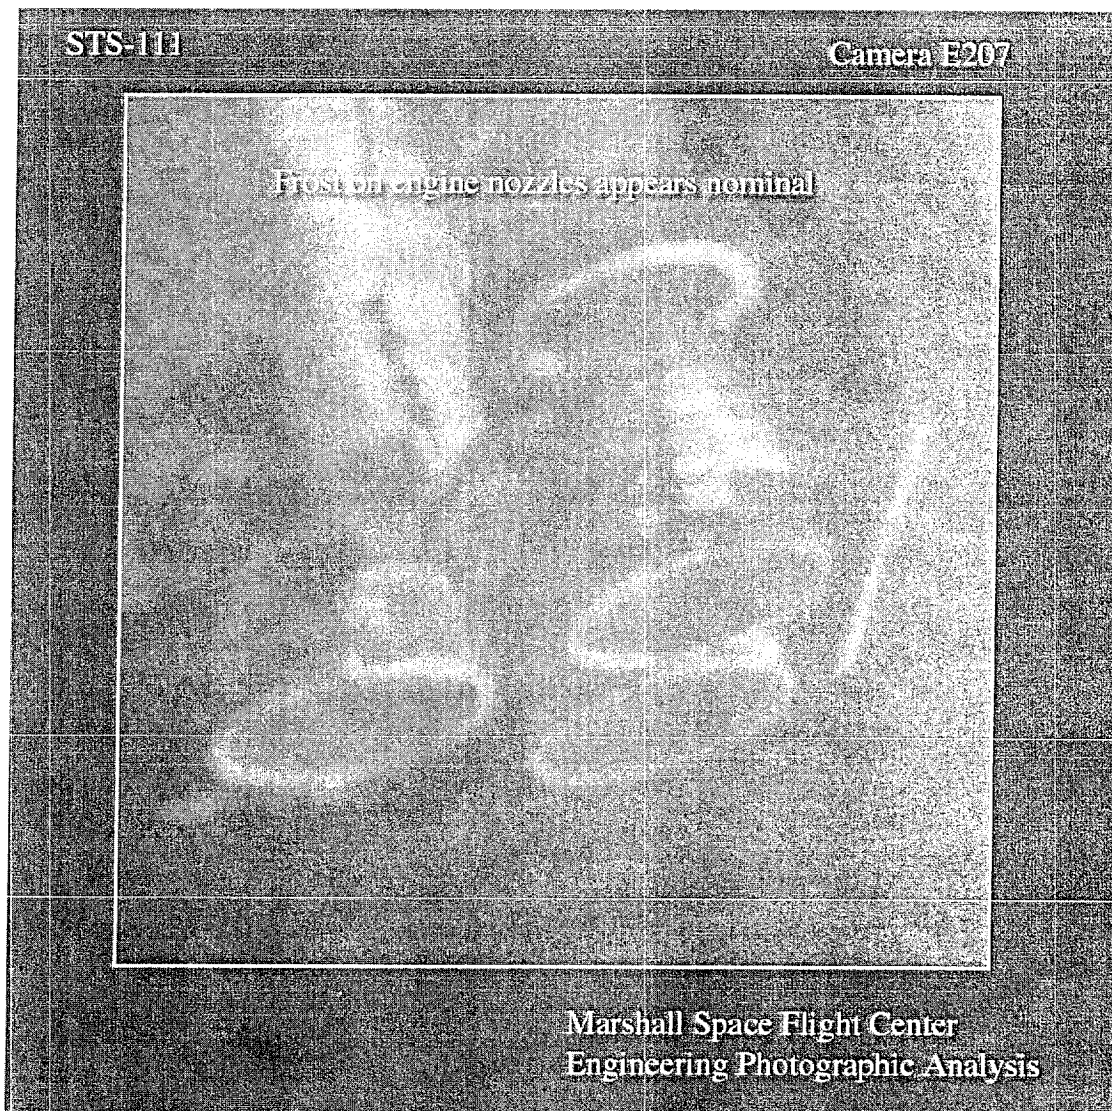
Figure 26. E207: Nominal Frost on SSME Nozzles

Film Camera E207: Nominal Frost on SSME Nozzles

Frost on SSME nozzles appears nominal.

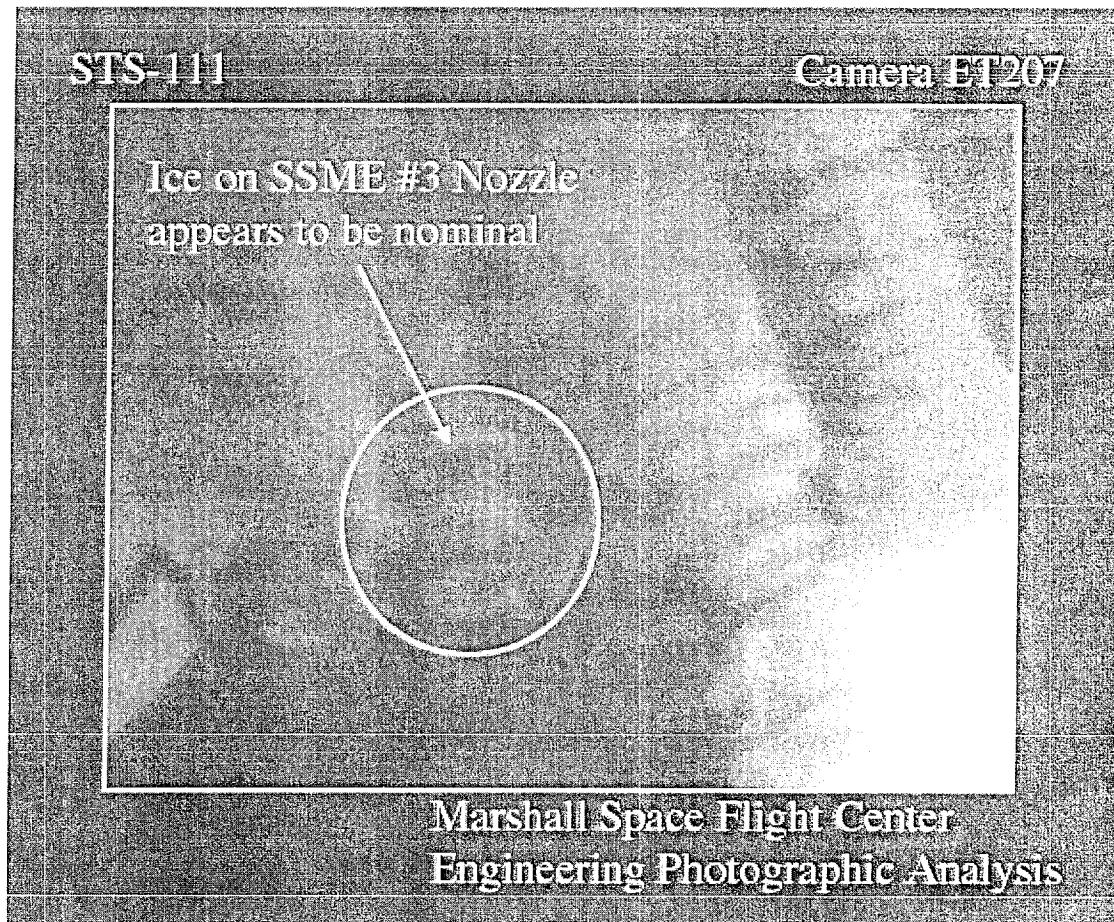
Figure 27. ET207: Nominal Frost on SSME#3 Nozzle

Video Camera ET207: Nominal Frost on SSME#3 Nozzle

Frost on SSME#3 nozzle appears nominal.
